PROPERTY CONDITION REPORT

# 5150 Gateway Commerce Blvd, San Antonio, TX 78219

Warehouse / Distribution · Condition assessment · July 26, 2026

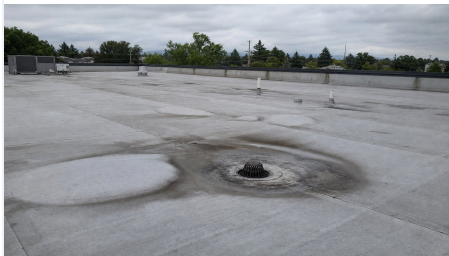
### #1 Roof membrane blistering (north bay)

HIGH

Widespread blistering observed across roughly 400 sq ft of the north bay TPO membrane, with two open seams near the drain. Active moisture staining below suggests intrusion.

**Recommended fix:** Engage a commercial roofer to assess and reseal affected sections within 30 days

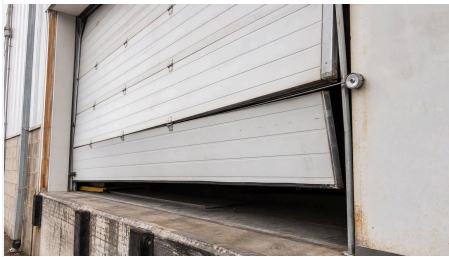
### #2 Loading dock door #3 off-track

HIGH

Overhead door #3 binds and jumps the track when cycled. Bent lower track section and two worn rollers. Pinch/entrapment risk to staff.

**Recommended fix:** Lock out door #3 and service the track and rollers before returning to use

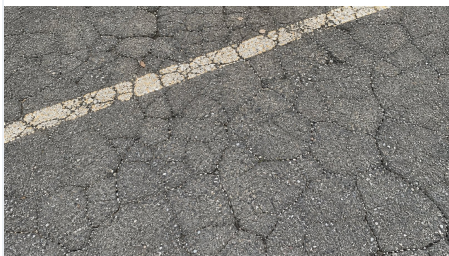
### #3 Parking lot cracking (NE corner)

MEDIUM

Alligator cracking across the northeast drive lane, ~120 linear ft. No trip hazards yet but water infiltration will accelerate base failure.

**Recommended fix:** Rout and seal cracks now; budget resurfacing within 12 months

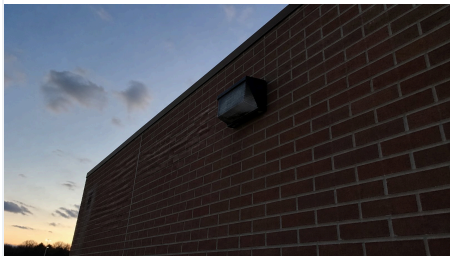
#4 Exterior wall-pack light out (east elevation)

LOW

One of four east-elevation wall packs is dark, reducing after-hours lighting near the employee entrance.

**Recommended fix:** Replace ballast/fixture on next maintenance pass
