Quarterly exterior photo survey. Four items flagged for follow-up: roof-membrane blistering, an off-track dock door, parking-lot cracking, and a failed exterior light. Photos below.

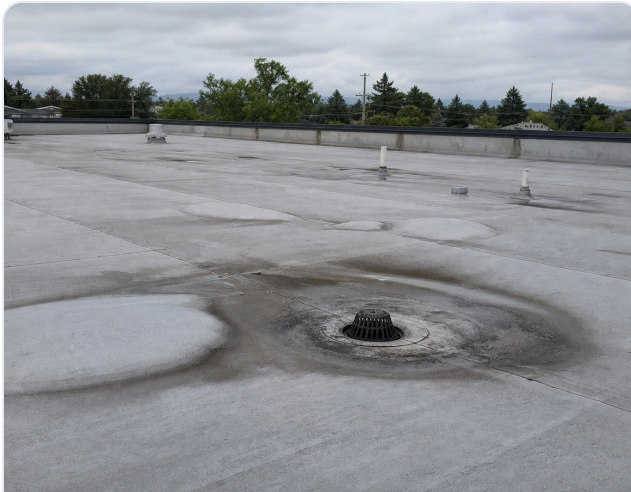
**#1 Roof — north bay****HIGH**

Membrane blistering and ponding near the primary drain.

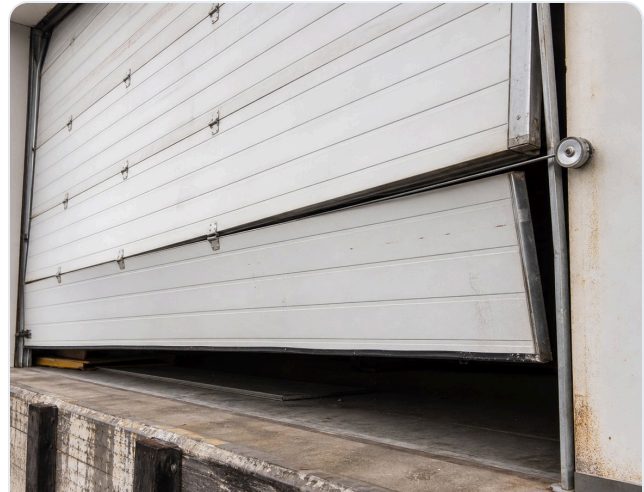
**#2 Loading dock door #3****HIGH**

Door off its track; bottom panel bent.

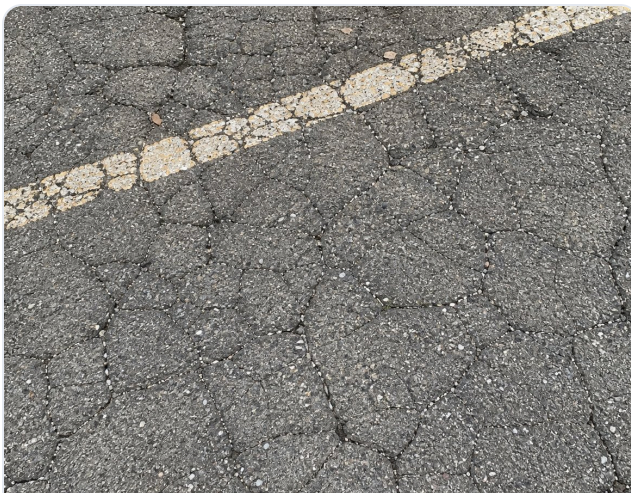
**#3 Parking lot — NE corner****MEDIUM**

Alligator cracking across the drive lane.

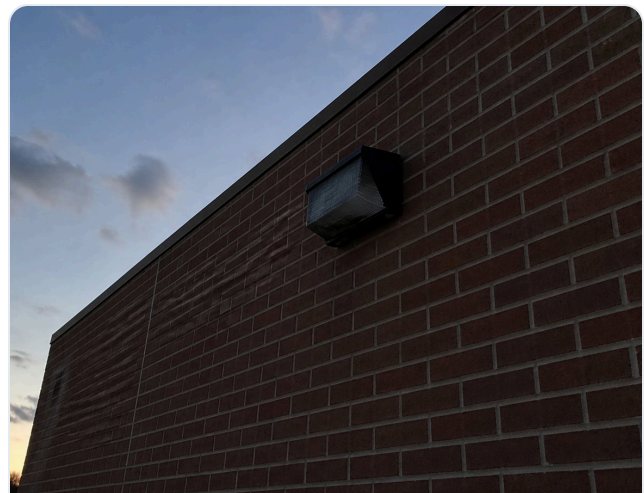
**#4 Exterior wall-pack (east)****LOW**

Fixture out; no illumination at dusk.
