| Site / Address | 3200 Eastgate Logistics Dr,<br>San Antonio, TX 78219 | Property type | Warehouse / Distribution |
| Service type | Service call | Date | July 29, 2026 |

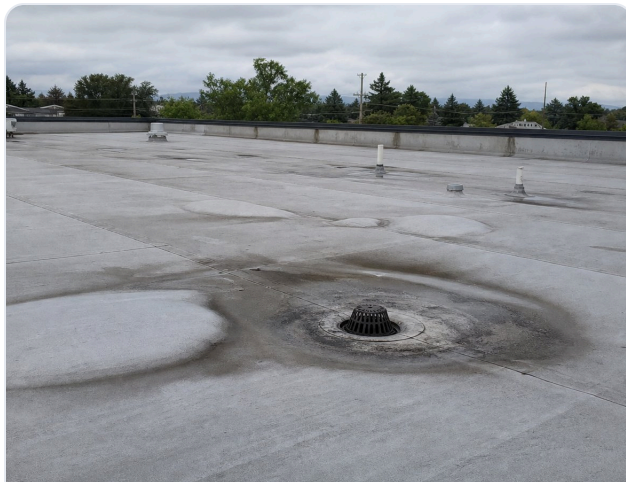
Roof membrane — north bay — Blistering and ponding near the primary drain; seams resealed.

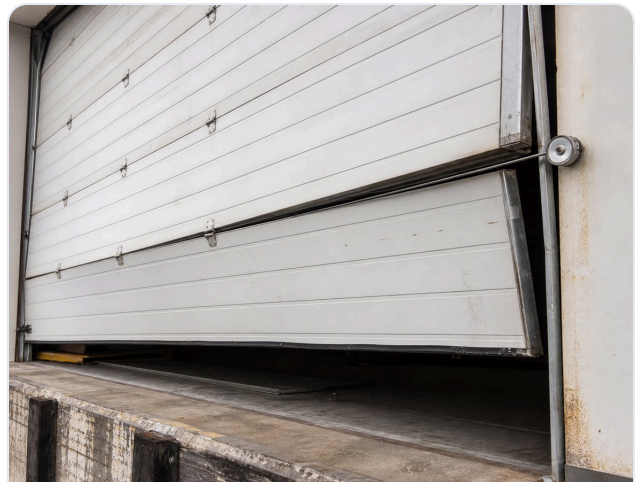
Loading dock door #3 — Door off its track; re-tracked and roller replaced.

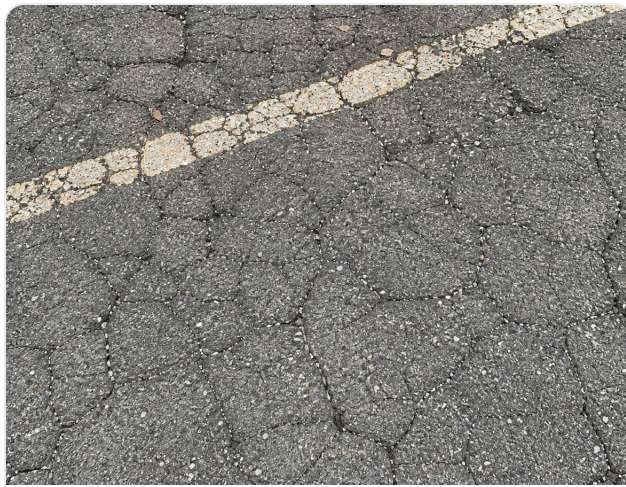
Parking lot — NE corner — Alligator cracking crack-filled.

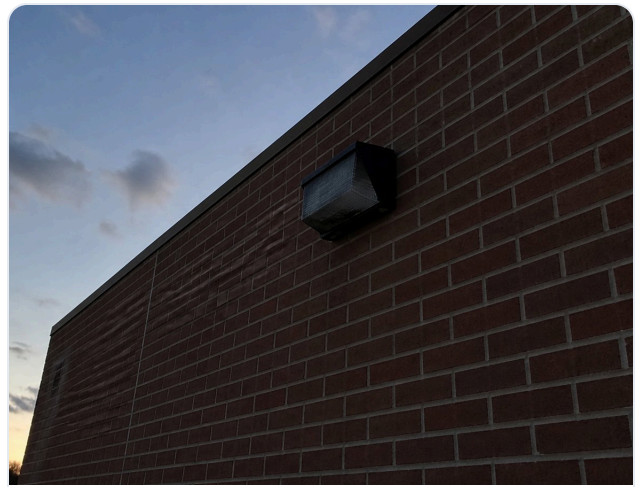
Exterior wall-pack (east) — Fixture out; replaced with LED.
